# DOT/FAA/CT-92/14

FAA Technical Center Atlantic City International Airport, N.J. 08405 Rotorcraft Ditchings and Water-Related Impacts that Occurred from

1. Report No.	2. Government Accession No.	3. Recipient's Catalog No.
DOT/FAA/CT-92/14		
4. Title and Subtitle		5. Report Date
ROTORCRAFT DITCHINGS AND WA	ATER-RELATED IMPACTS THAT	October 1993
OCCURRED FROM 1982 TO 1989	PHASE II	6. Performing Organization Code
7. Author(s)		Performing Organization Report No.
Mark Muller, Galaxy Scients Lindley W. Bark, Simula Ind		
9. Performing Organization Name and Address		10. Work Unit No. (TRAIS)
Galaxy Scientific Corporati 2500 English Creek Avenue, Pleasantville, NJ 08232		
		11. Contract or Grant No.
		DTFA03-89-C-00043
12. Sponsoring Agency Name and Address		13. Type of Report and Period Covered
U.S. Department of Transport Federal Aviation Administra Technical Center Atlantic City International	ation	Final Report
•		14. Sponsoring Agency Code ACD-210

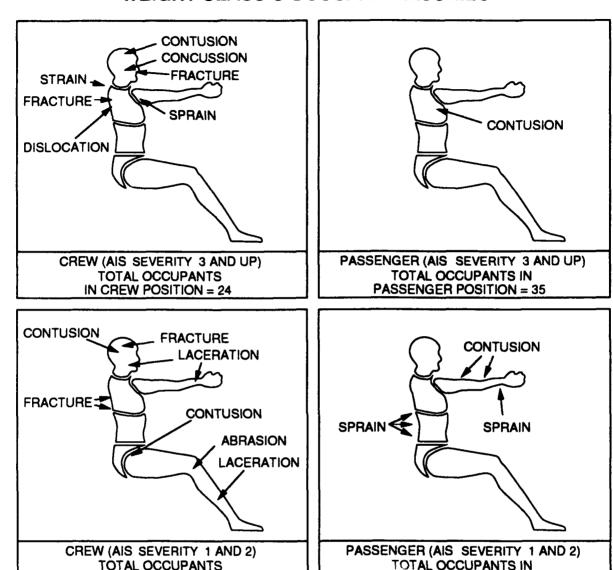
FIGURE 2. IMPACT INJURIES CLASSIFIED BY TYPE, SEVERITY, AND BODY LOCATION FOR ROTORCRAFT WEIGHT CLASS C OCCUPANTS

These figures show that serious impact injuries of the back, torso, and head, which can be debilitating and costly, were observed in occupants of both weight classes. The injuries depicted on the arms and legs further demonstrates flailing to be a significant injury mechanism experienced in water impacts. It should be noted that there is a bias towards crew injuries in weight class B because of the higher number of occupants in the sample that were seated in crew positions.

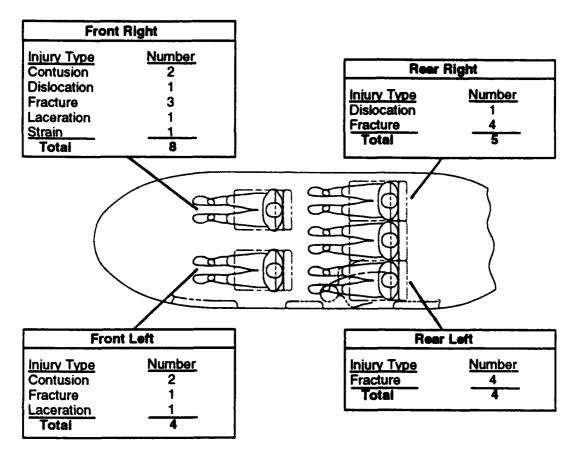
FIGURE 3. OCCUPANT IMPACT INJURY TYPES (AIS SEVERITY 3 AND UP)
BY SEATING LOCATION, ROTORCRAFT WEIGHT CLASS B

Figure 3 and figure 4 show impact injuries relative to a top view of occupant seating position to further demonstrate that similar injury types were experienced by occupants throughout the rotorcraft. Even considering the effect of the bias towards crew injuries as mentioned, crew occupants still suffered more impact injuries than passengers. The proximity of the crew to equipment such as the instrument panel and flight controls, which can cause injury during flailing, is believed to account for the increased frequency of crew injury. No significant differences in injury types by seating location were observed when categorizations by scenario type were performed.

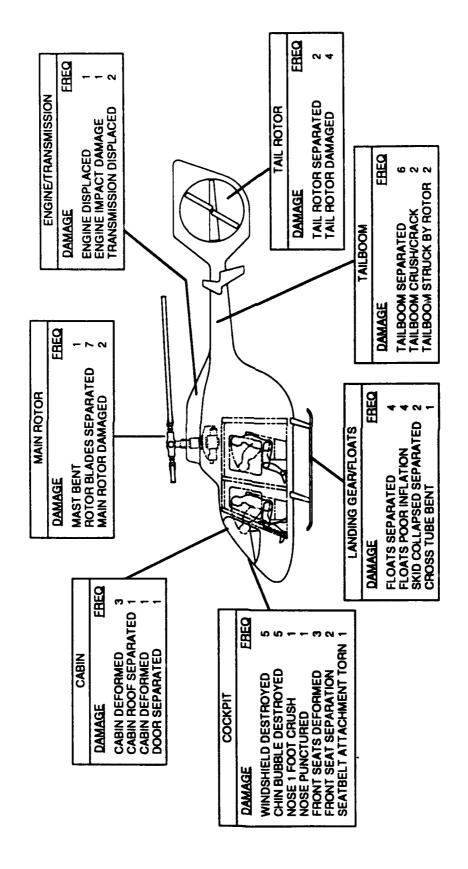
SUMMARY OF IMPACT DAMAGE FOR WEIGHT CLASS B ROTORCRAFT FIGURE 5.

The results of the rotorcraft damage categorization were summarized by rotorcraft weight class. Figure 5 presents a composite summary of damage that was experienced by rotorcraft of weight class B. A total of 15 of the 22 weight class B rotorcraft impacts that were defined by scenarios had detailed impact damage descriptions. The damage was categorized by the airframe component affected, the type of damage suffered, and the frequency of damage reported.

<u>Cockpit and Cabin</u> — The cockpit and cabin section of the rotorcraft together comprise the occupied volume which must be maintained around the occupants. The most frequently occurring type of damage noted to the cockpit was breakage of the windshield and chin bubbles at impact, which probably contributed to lacerations received by occupants in crew seating locations. Some crush and penetration of the nose structure was also noted. Deformation of seats was observed and indicates high impact accelerative forces which is consistent with the impact injuries received. Separation of seats from the rotorcraft can be

a significant cause of occupant injury but was noted in only two cases. The separation of the cabin roof occurred in a severe but partially survivable accident which had a nose-down impact. This accident does not represent a typical water accident event; however, it is included for completeness.

<u>Engine/Transmission</u> — The engine and transmission represent large masses above the occupants (figure 5). This mounting configuration provides the potential for these masses to break loose and enter the occupied cabin volume. Although there were two occurrences of the transmission being displaced, these components were successfully retained in the 22 accidents examined.

<u>Landing Gear/Floats</u> — Damage to the landing gear was observed in only two cases and suggests that the skid landing gear does not contribute to energy absorption in water impacts. Float separation and poor inflation was noted in several cases and demonstrates the deficiencies in rotorcraft flotation equipment as reported in reference 1.

<u>Main Rotor</u> — Separation or other damage to the main rotor blades were frequently recorded. Several blades were damaged due to contact with either the tail boom or the water as the downed rotorcraft rolled. There were no recorded occurrences of main rotor damage contributing to occupant injury.

<u>Tail Boom/Tail Rotor</u> — Damage to the tail boom and tail rotor, especially separation from the rotorcraft, was observed frequently. Impact damage to these components, however, generally does not affect occupant survivability.

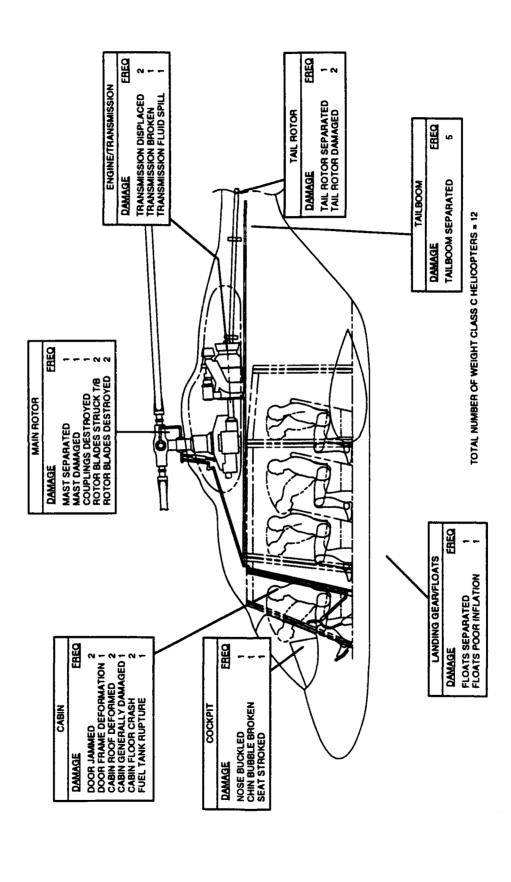
SUMMARY OF IMPACT DAMAGE FOR WEIGHT CLASS C ROTORCRAFT FIGURE 6.

The results of the rotorcraft damage categorization for weight class C is presented in figure 6. A total of 9 of the 12 class C rotorcraft impacts defined by scenarios contained detailed impact damage descriptions. The damage was organized by the airframe component affected, the type of damage suffered, and the frequency of damage reported.

Cockpit and Cabin — Damage to the cockpit of weight class C rotorcraft was similar in type to that received by weight class B rotorcraft, though the frequency of windshield and chin bubble breakage was significantly lower in weight class C. Floor crush and cabin roof deformation are notable damage types because they may reduce the occupiable volume, however this damage was not reported to have caused injuries. Fuel tank rupture is significant because of the potential for post-crash fire, but none were reported. Fuel spilled onto the water was noted to have caused two cases of chemical burns. Deformation of door frames or jamming of a door can impede occupant egress but this damage was not frequent.

<u>Engine/Transmission</u> — Transmission displacement was noted but did not penetrate the occupiable volume. The spillage of transmission fluid was not reported to have caused any injury.

<u>Landing Gear and Floats</u> — Separation and inflation problems with rotorcraft flotation equipment was noted.

Main Rotor — The mast and main rotor blades were damaged but this damage was not a contributor to injury.

<u>Tail Boom/Tail Rotor</u> — Separation of the tail boom occurred frequently and occurrences of tail rotor damage were also noted. This damage was not reported to contribute to injury of occupants.
